BUREAU OF SHIPS GROUP TECHNICAL INSPECTION REPORT

OPERATION CROSSROADS. U.S.S. INDEPENDENCE (CVL22)

TEST ABLE

VOLUME 1 OF 4 [U].

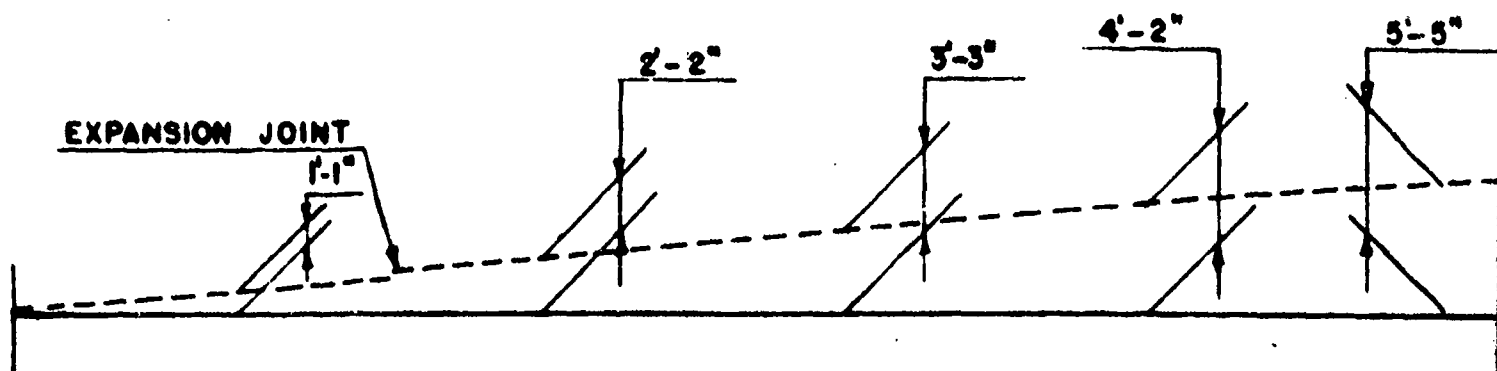
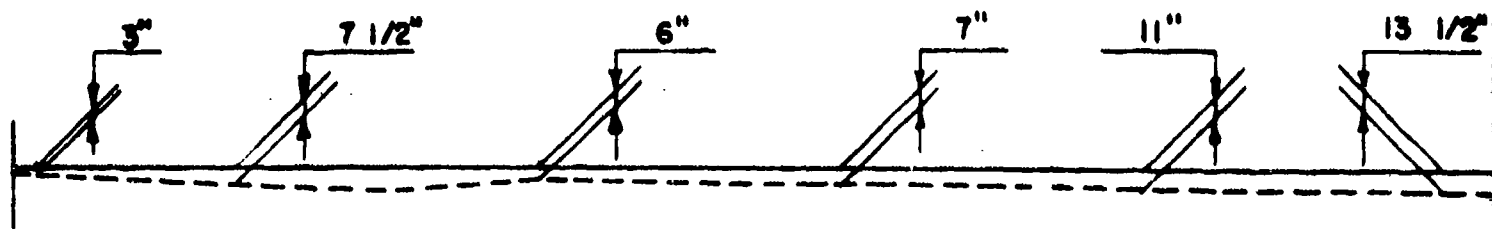
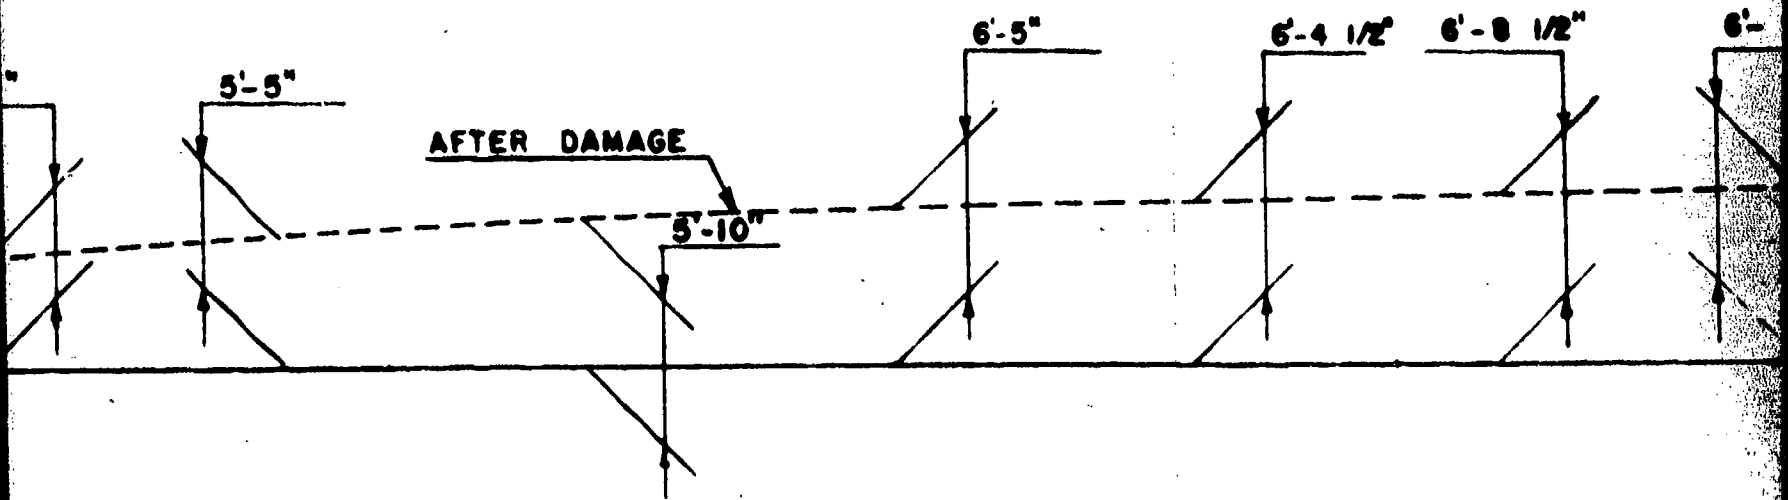
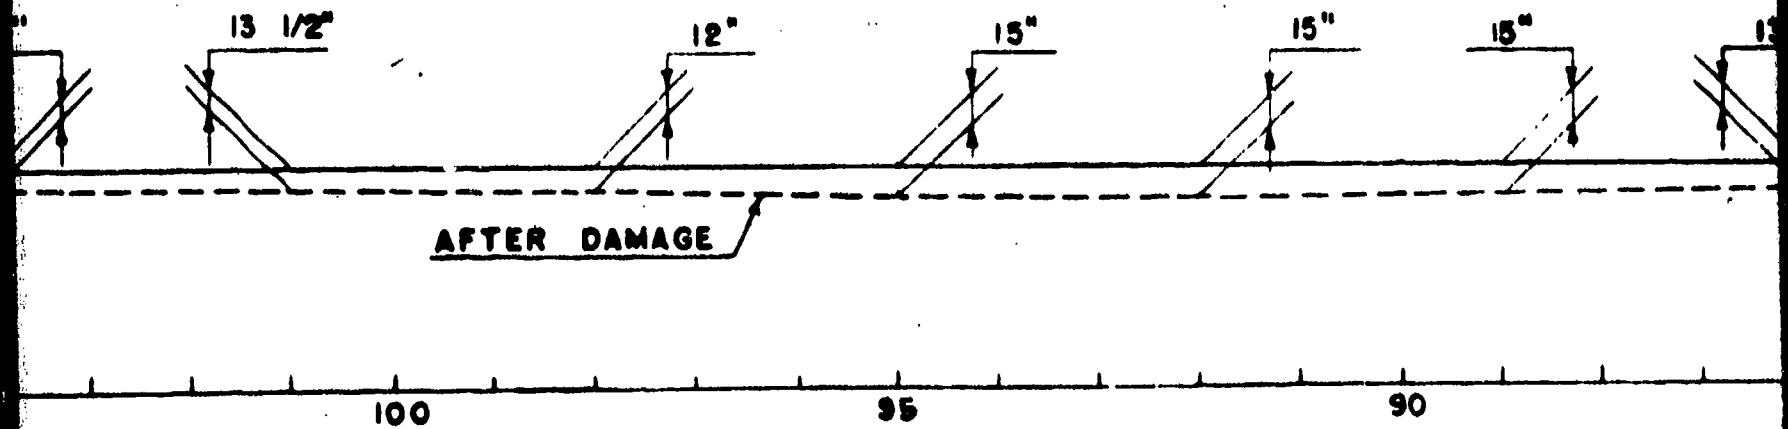
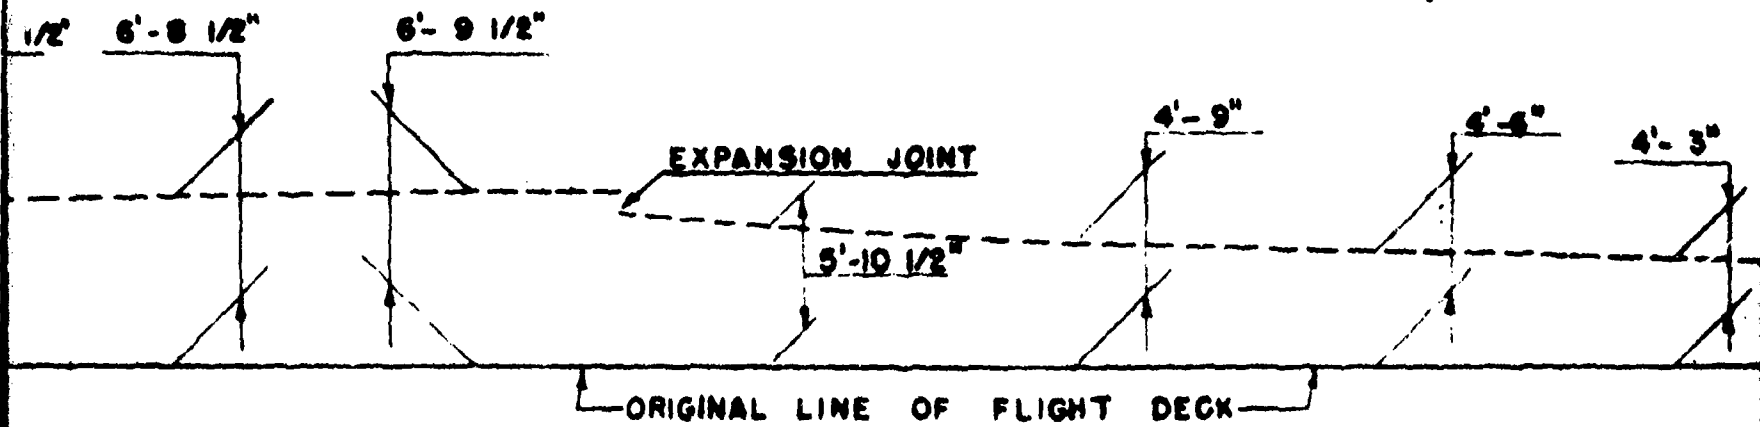
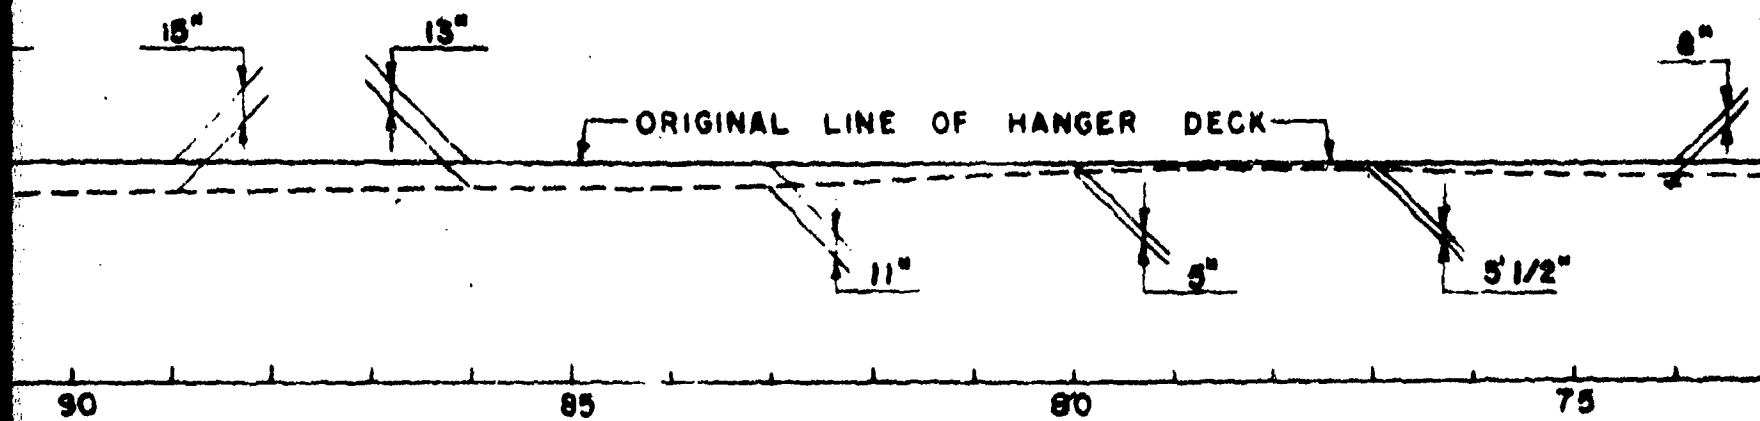
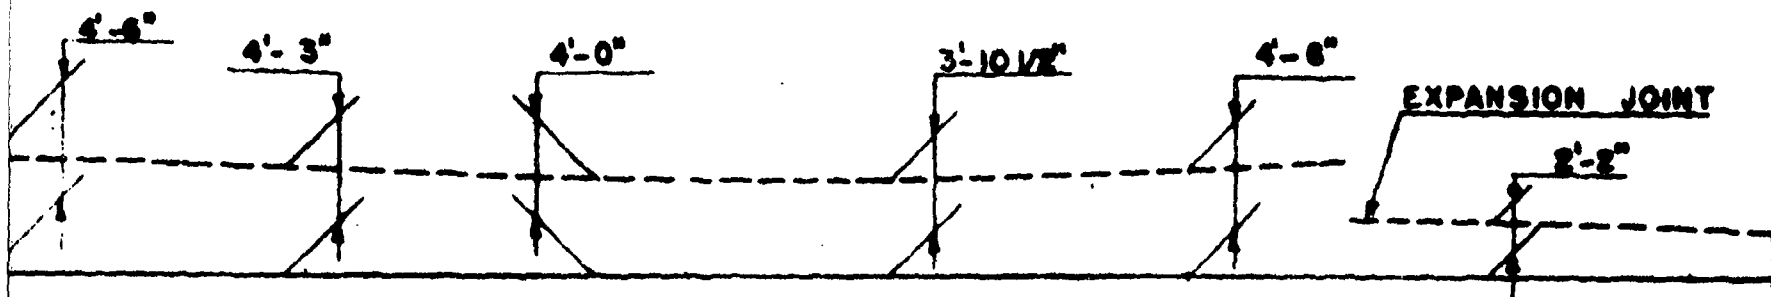
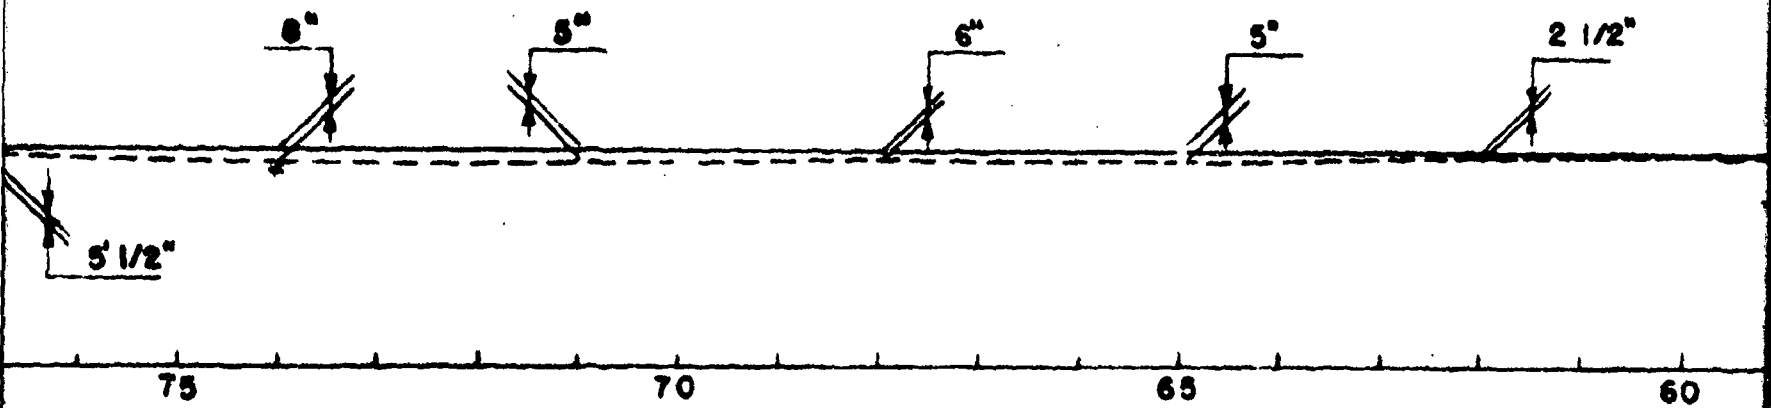
PLATE NO. 3

Beginning at the expansion joint, frame 63 1/2, the flight deck is very sharply hipped along the centerline with the wood decking broken, and several feet of the thin steel deck plating below is split. Between the expansion joints at frames 63 1/2 and 84 1/2 the deck, on the starboard side, begins to rise at the deck edge and progresses in a straight line to the hip at the centerline. On the port side between these frames there is little change from the normal position of the deck between the edge and approximately eleven feet inboard of it. From here the deck peaks sharply in a straight line to the hip at the center. In addition to the transverse deformation, the longitudinal run of the deck rises from 63 1/2 in a fair curve to about 7 feet above normal at frame 84 1/2. The sharp peaking disappears at about frame 80 where it fades into a smooth arch which continues past the expansion joint at frame 84 1/2. Except for the splintering of the wood at breaks along the centerline the surface of the deck is in materially good condition.

Between the expansion joints at frames 84 1/2 and 111 1/2, the flight deck drops in a relatively smooth curve from about 7 feet above normal to a generally normal position at 111 1/2. The ridge in this area is more pronounced because the deck maintains its normal position for about nine feet inboard of the deck edge both port and starboard, thus making a much sharper angle of rise. The wood decking here is also splintered and broken and the thin steel plating

ELEVATION
FLIGHT DECK & HANGER DECK CENTERLINE

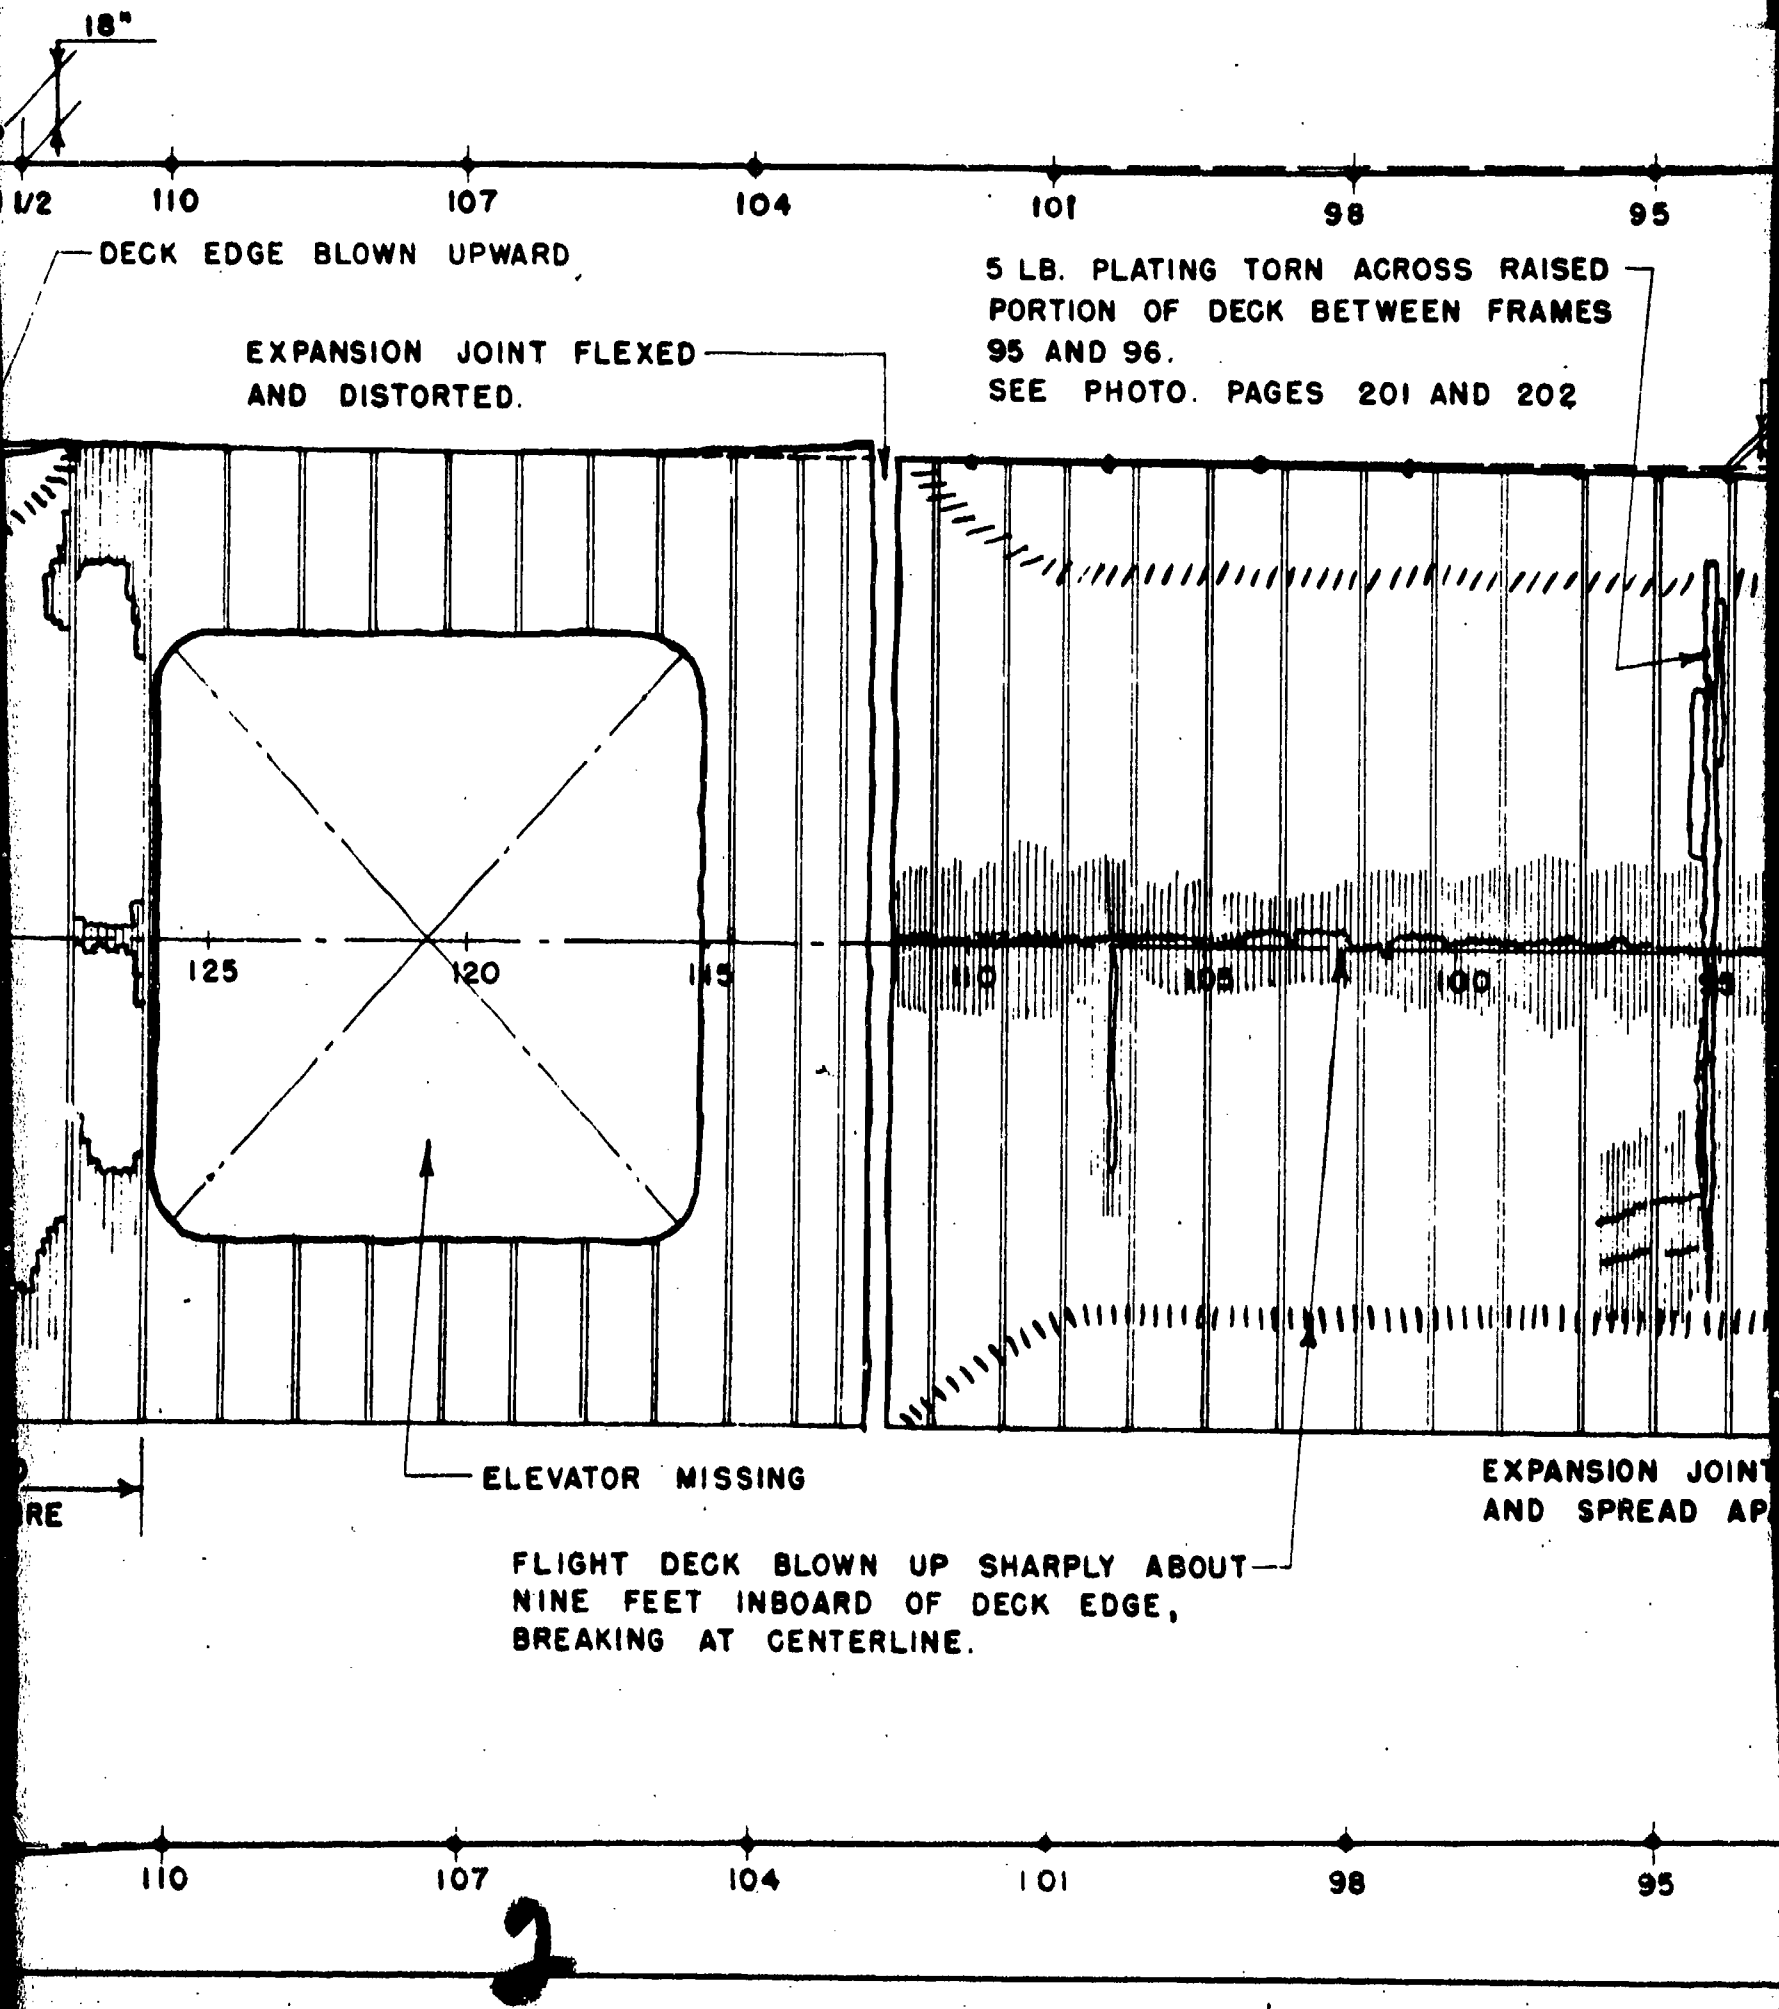
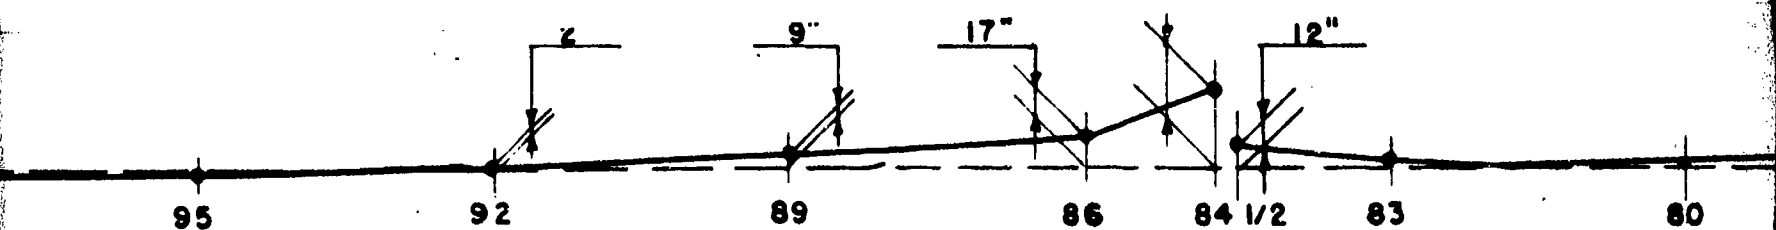
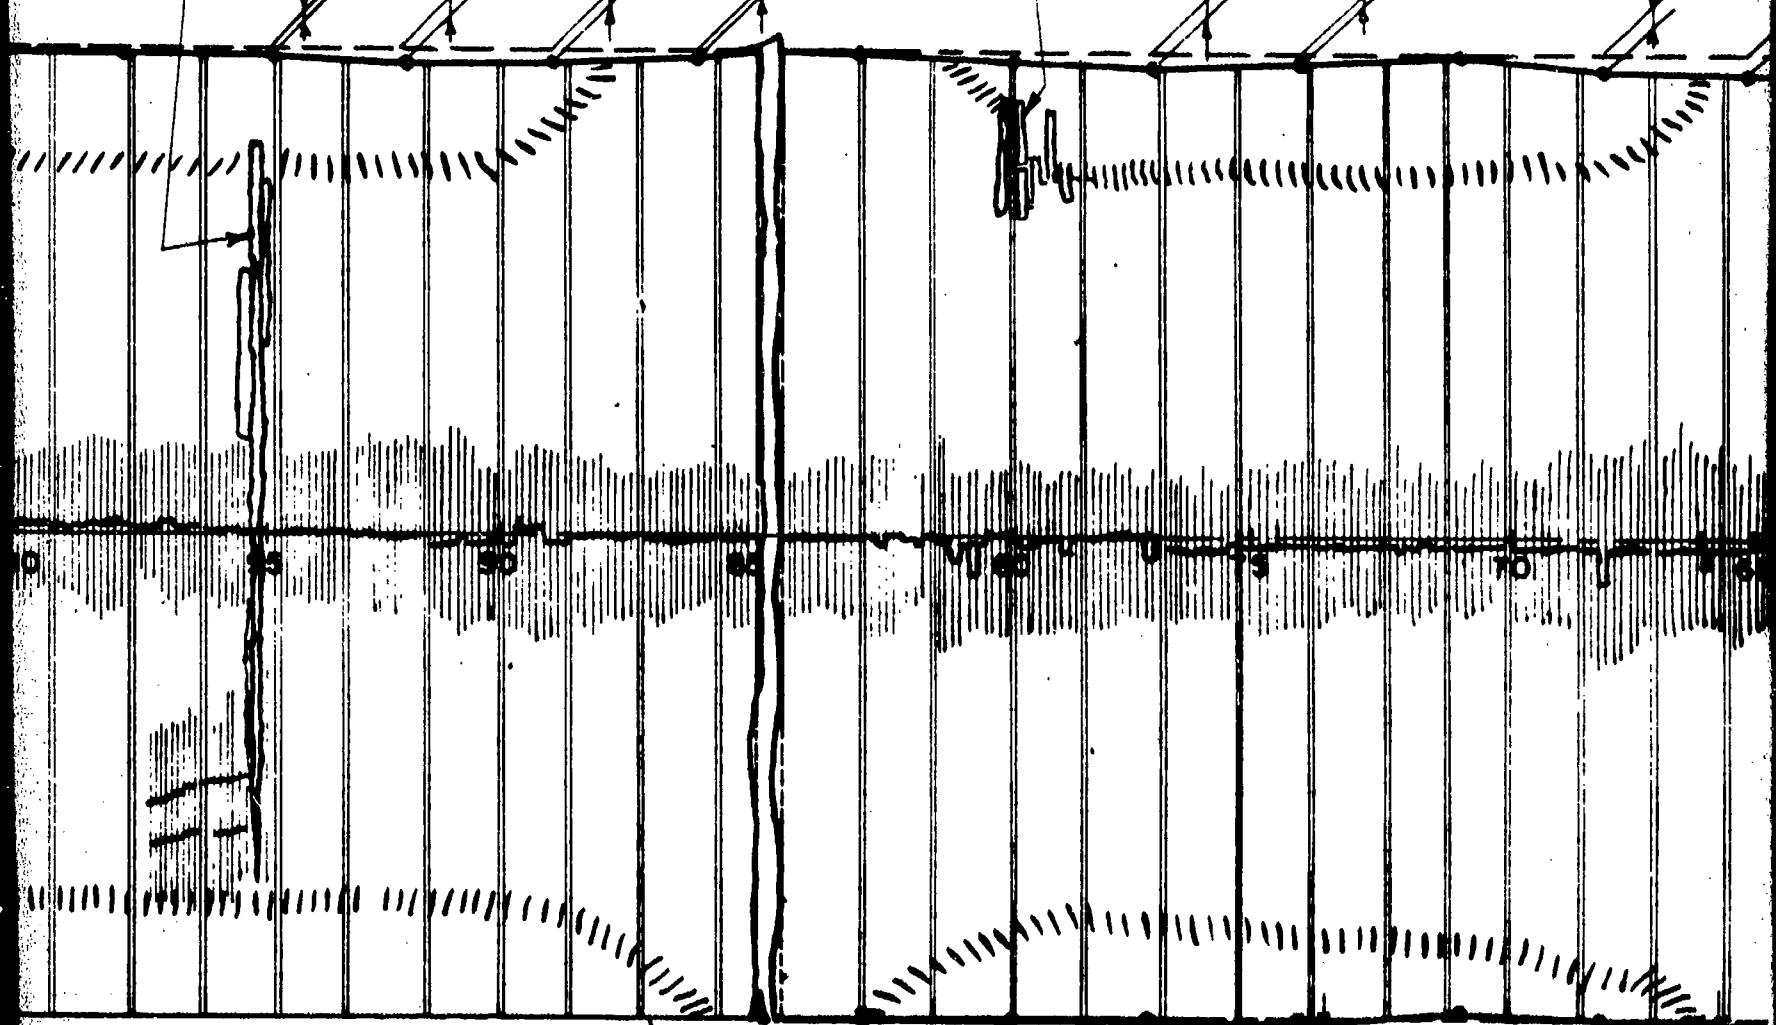
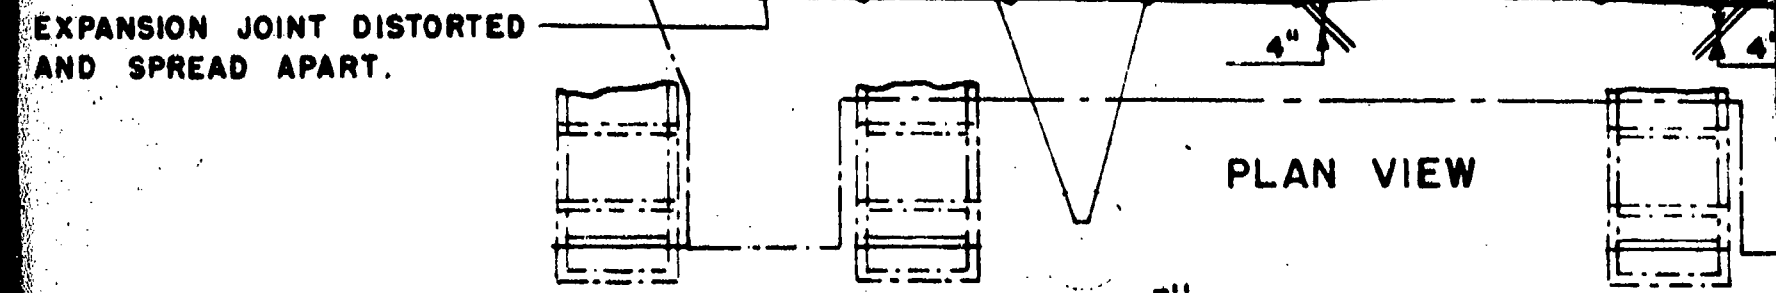
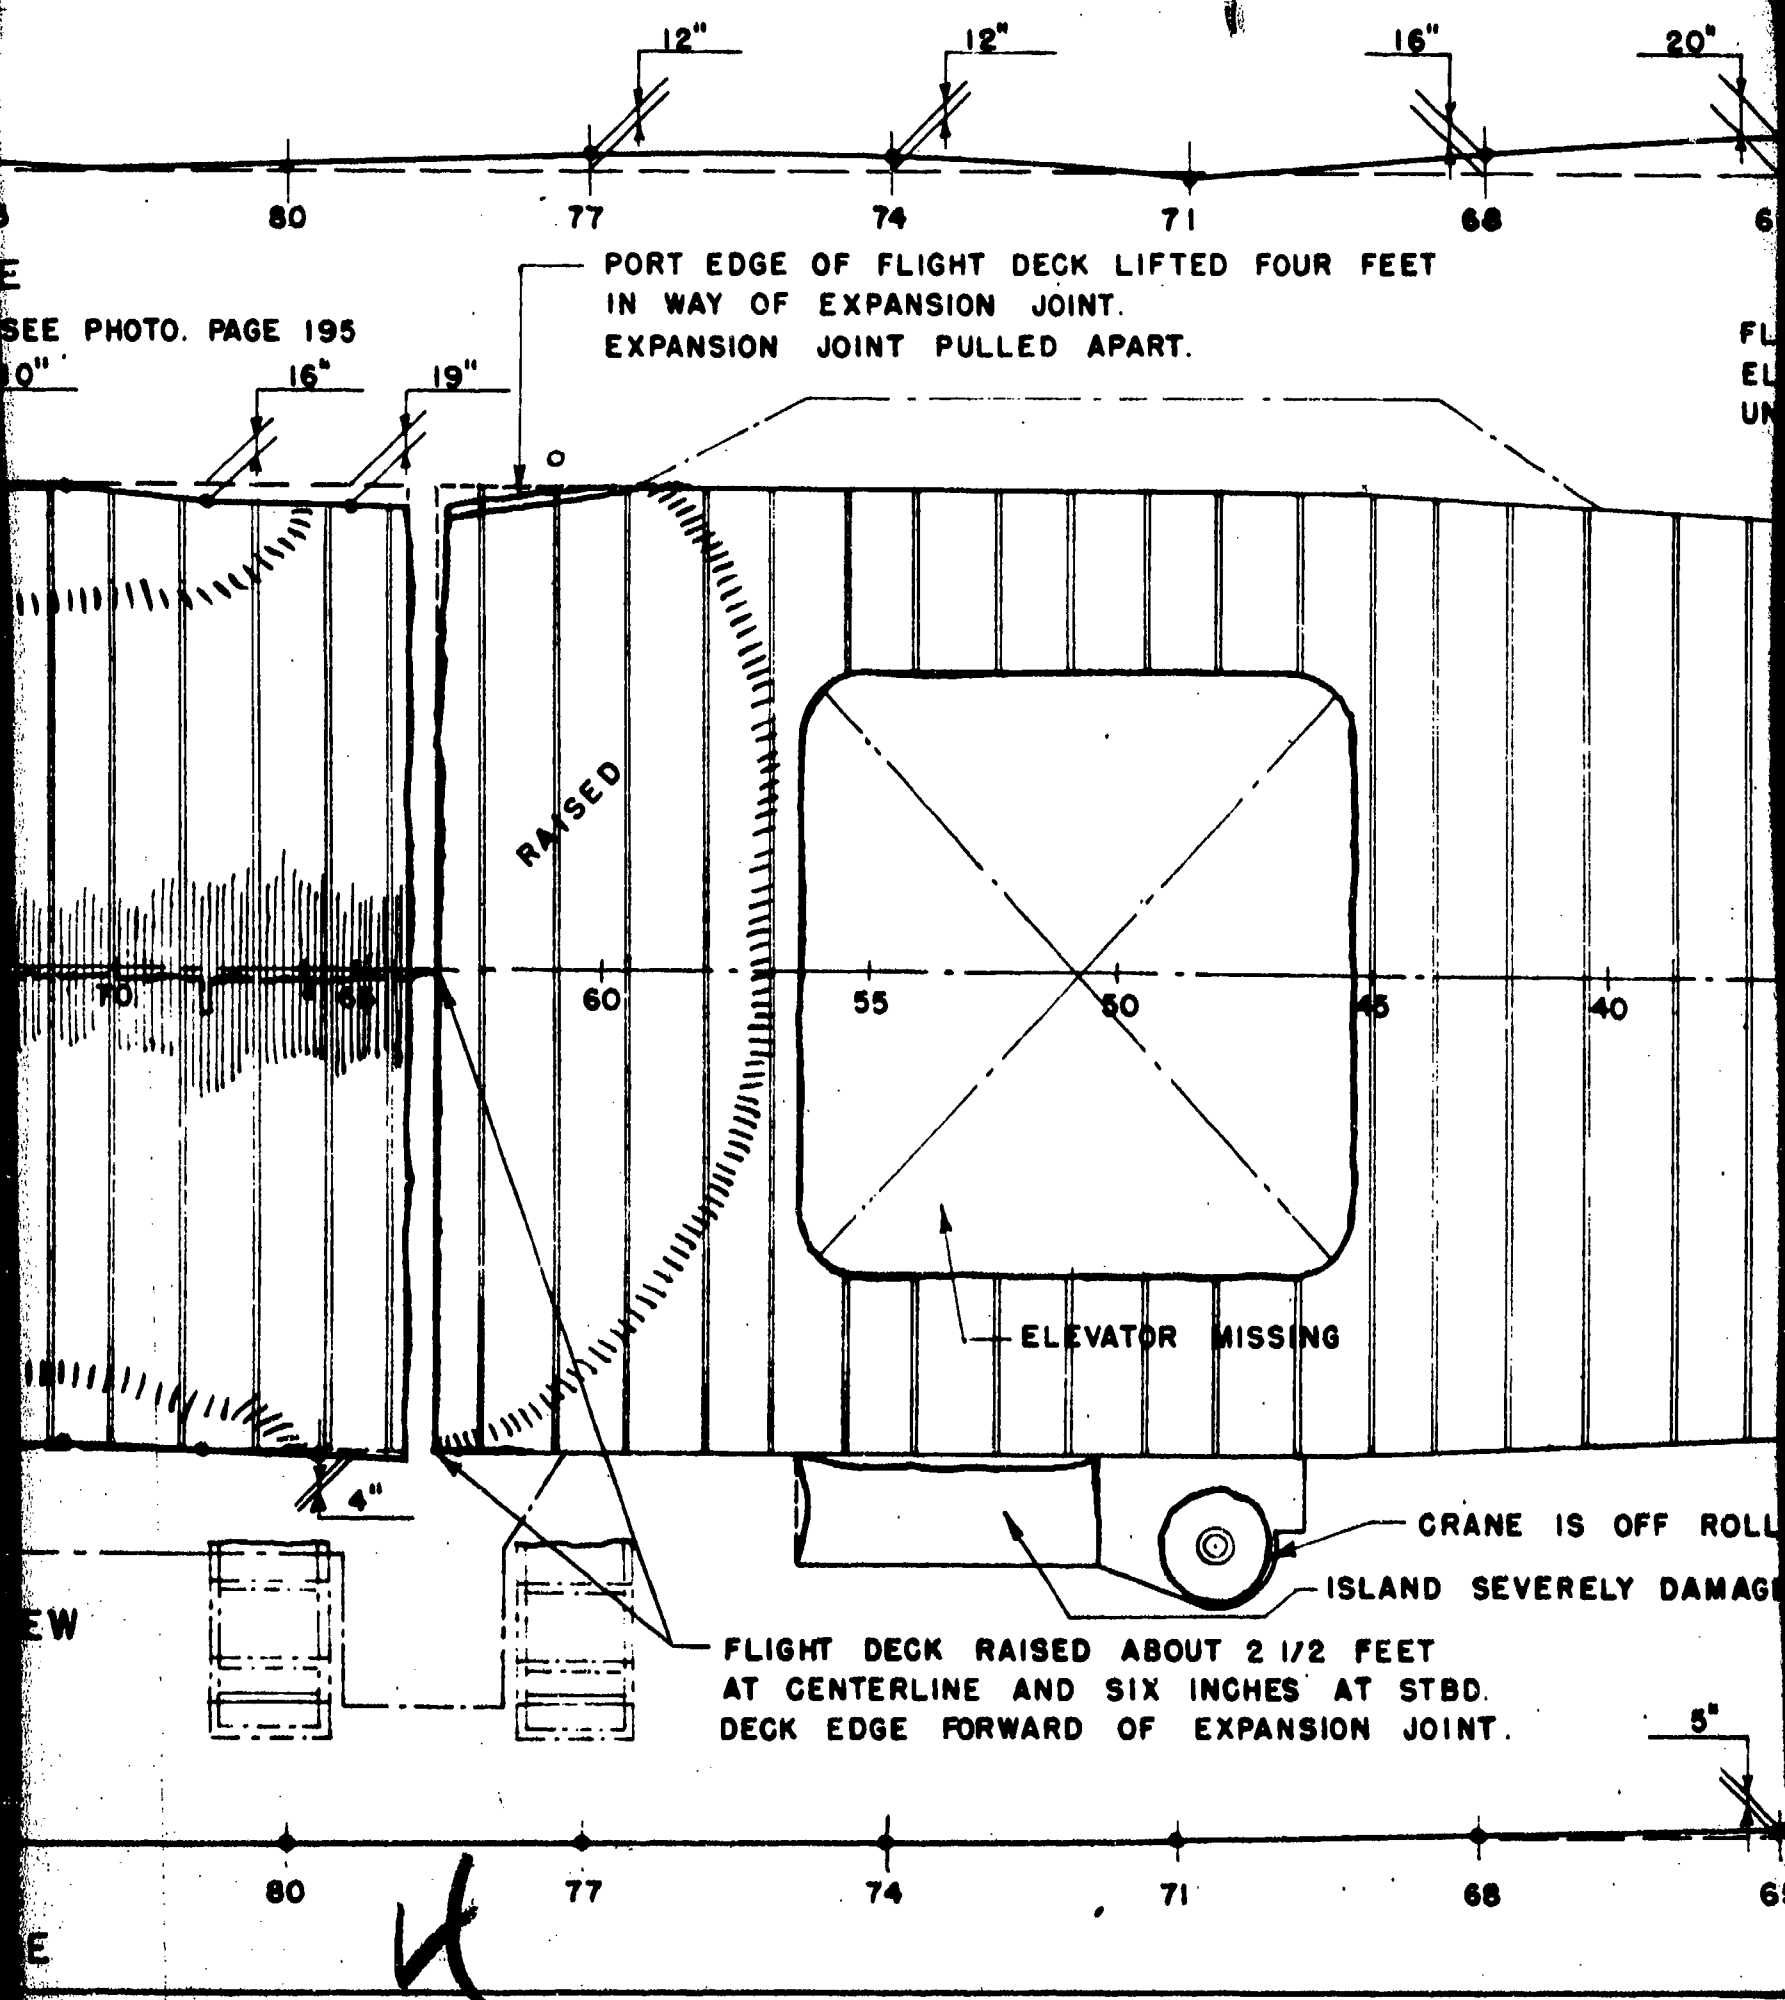
PLATE NO. 4

Plate No. 4 is based on survey measurements of the flight deck, before and after the test, and shows that there was relatively little movement of the edges of the flight deck, particularly in the horizontal plane. The edges forward of frame 63 1/2 and aft of 111 1/2 appear to have held position very well. The starboard edges of the two middle sections are very nearly in line. The variation shown by the port edges of the two middle sections is due primarily to the deformation of the vertical columns beneath, although there is some evidence of a small clockwise twisting of the middle sections. Such evidence is; twisting in the columns of the flight deck bents, the unequal opening of the expansion joint at frame 111 1/2, and the slight starboard translation of the deck at frame 63 1/2. Plate 4 also shows the vertical displacements of the port and starboard deck edges is greatest at the expansion joints, these being in way of the wobble bent columns. It is significant that there is little vertical displacement at the starboard edge where the wobble columns generally held well but is very pronounced on the port side where the wobble columns tore loose. The slight movement starboard is attributed to the slight lifting of the pads under the starboard columns. The centerline of the flight deck is sharply peaked between the elevators from blast pressure which entered the hangar space through the port side. Detail discussion of the four areas follows:

FLIGHT DECK BADLY WARPED AND
WOOD DECKING BURNED FROM FIRE
BELOW.

RAISED FRAMES
 D 202
 ELEVATION - PORT DECK EDGE
 5 LB. DECK TORN SEE PHOTO. PAGE 195

3
 ELEVATION - STBD. DECK EDGE

FLIGHT DECK ABREAST AND FORWARD OF FORWARD ELEVATOR IS SLIGHTLY DISTORTED BUT ESSENTIALLY UNDAMAGED.

CRANE IS OFF ROLLER PATH
ISLAND SEVERELY DAMAGED AND TOP-HAMPER MISSING
